Photo 1 – Crosswinds Dairy, 98 Martell Rd., Alburgh, VT – 05/20/15
Concrete berm wall added at the Main Stack silage pad.

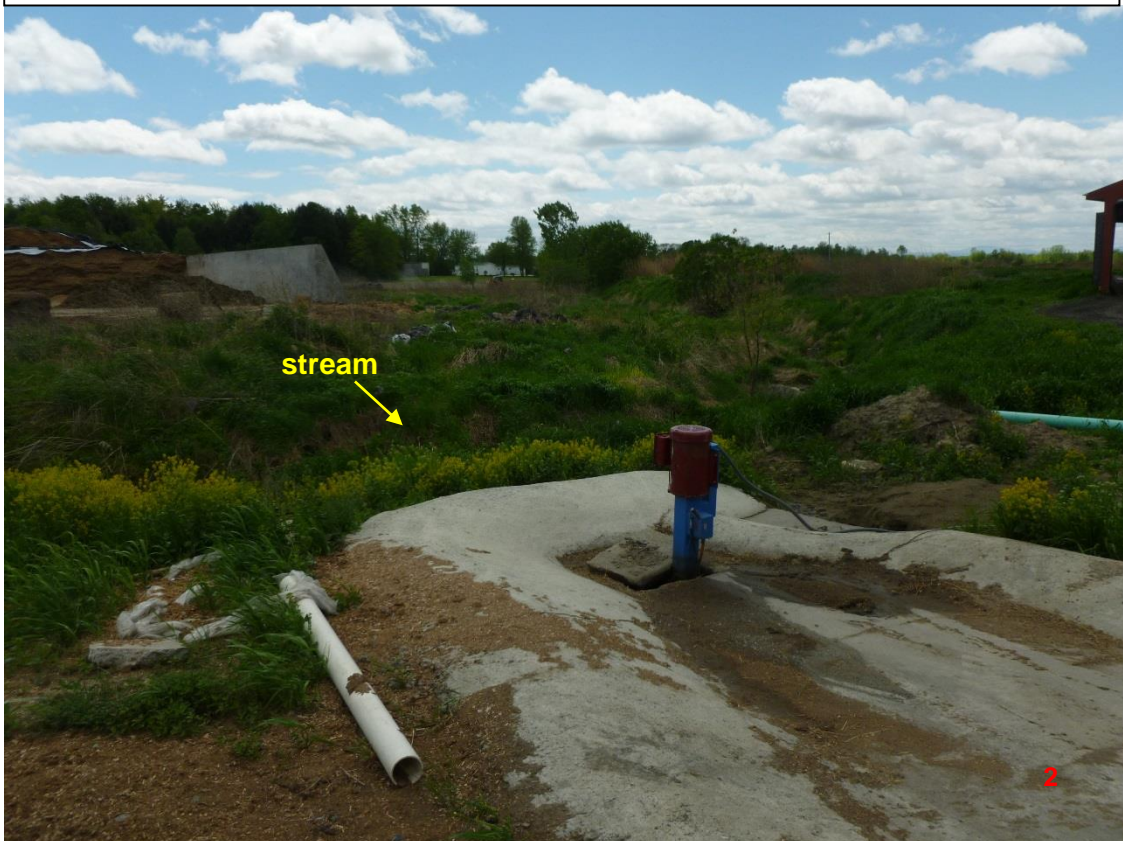
Photo 2 – Crosswinds Dairy, 98 Martell Rd., Alburgh, VT – 05/20/15
Collection tank for surface runoff between the T-Barn and Milking Barn.

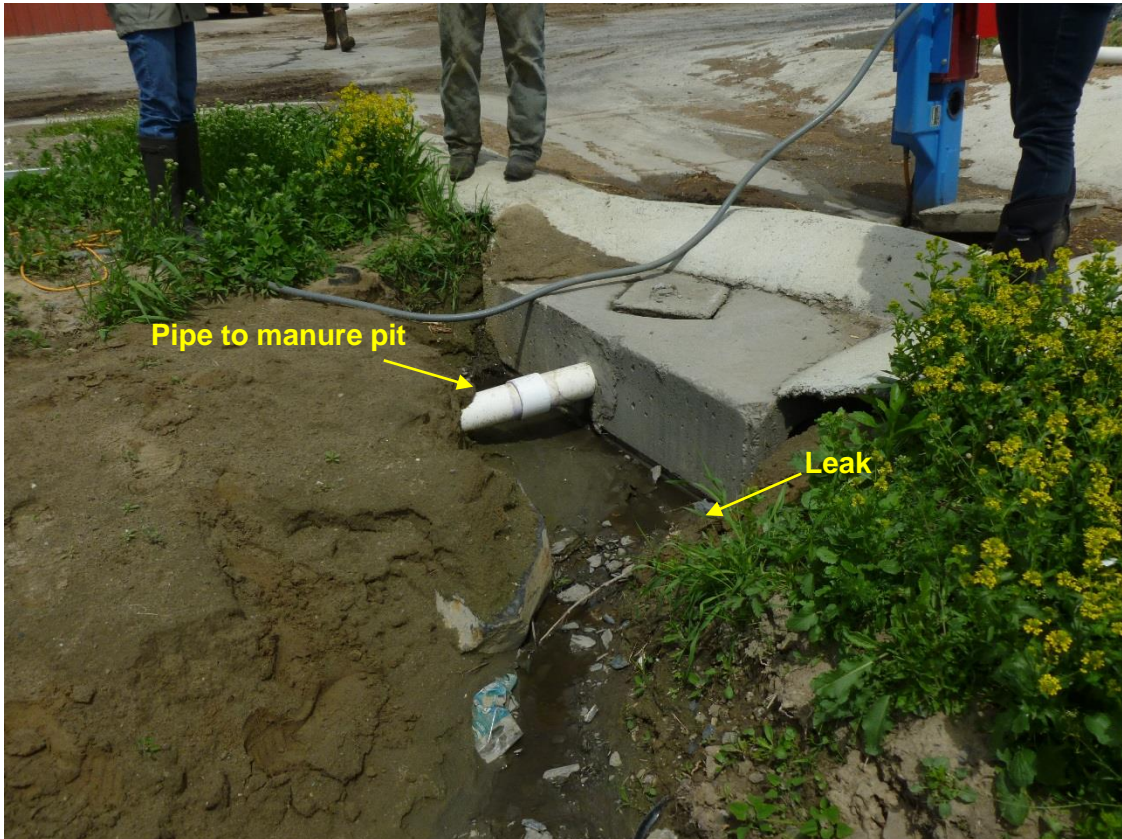
Photo 3 – Crosswinds Dairy, 98 Martell Rd., Alburgh, VT – 05/20/15
Location of water leak/seepage below the concrete slab and collection tank.

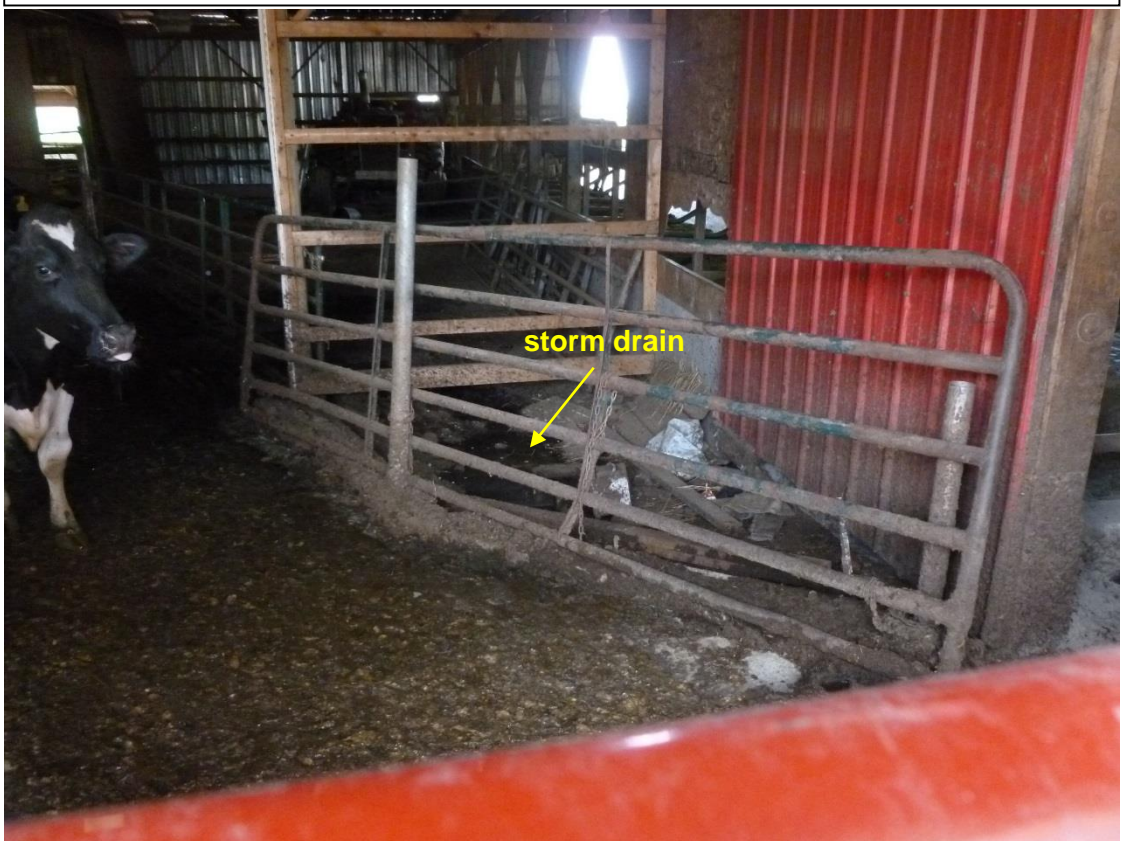
Photo 4 – Crosswinds Dairy, 98 Martell Rd., Alburgh, VT – 05/20/15
Covered animal walkway with low curbing and adjacent storm drain.

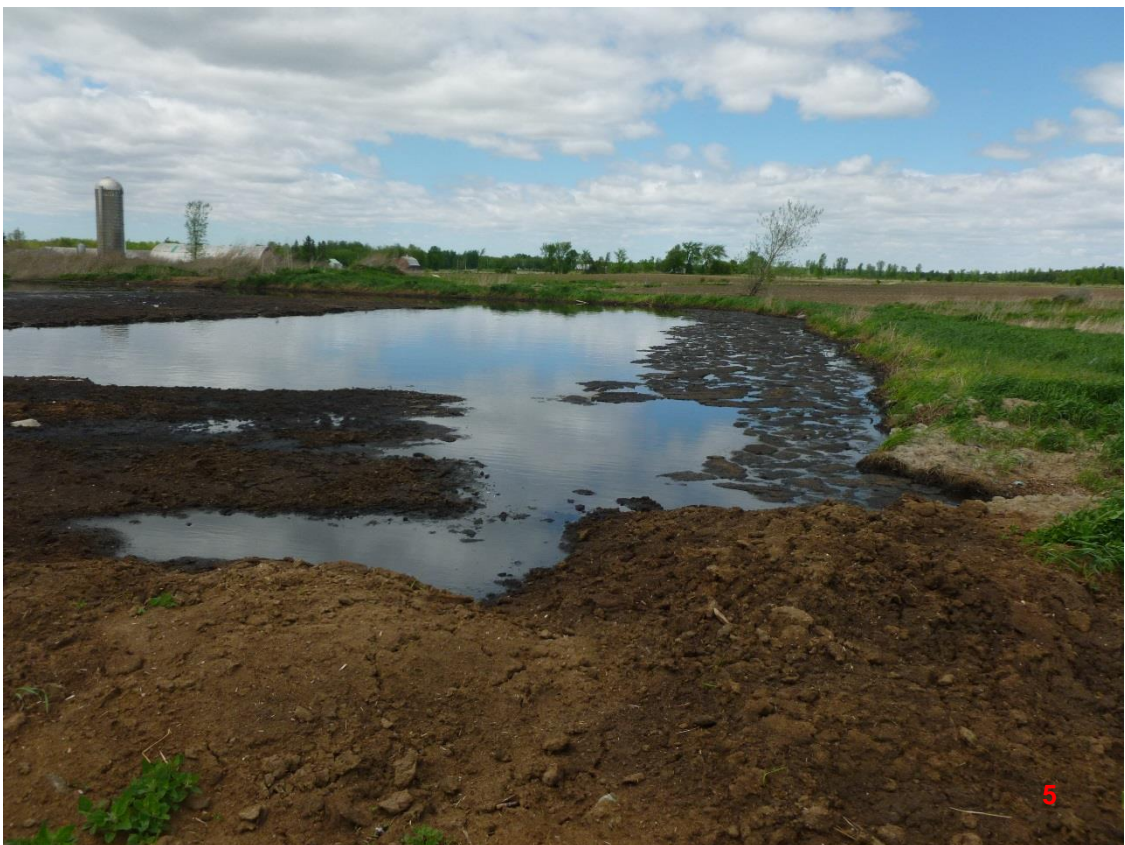
Photo 5 – Crosswinds Dairy, 98 Martell Rd., Alburgh, VT – 05/20/15
2nd manure pit, with volume nearing capacity

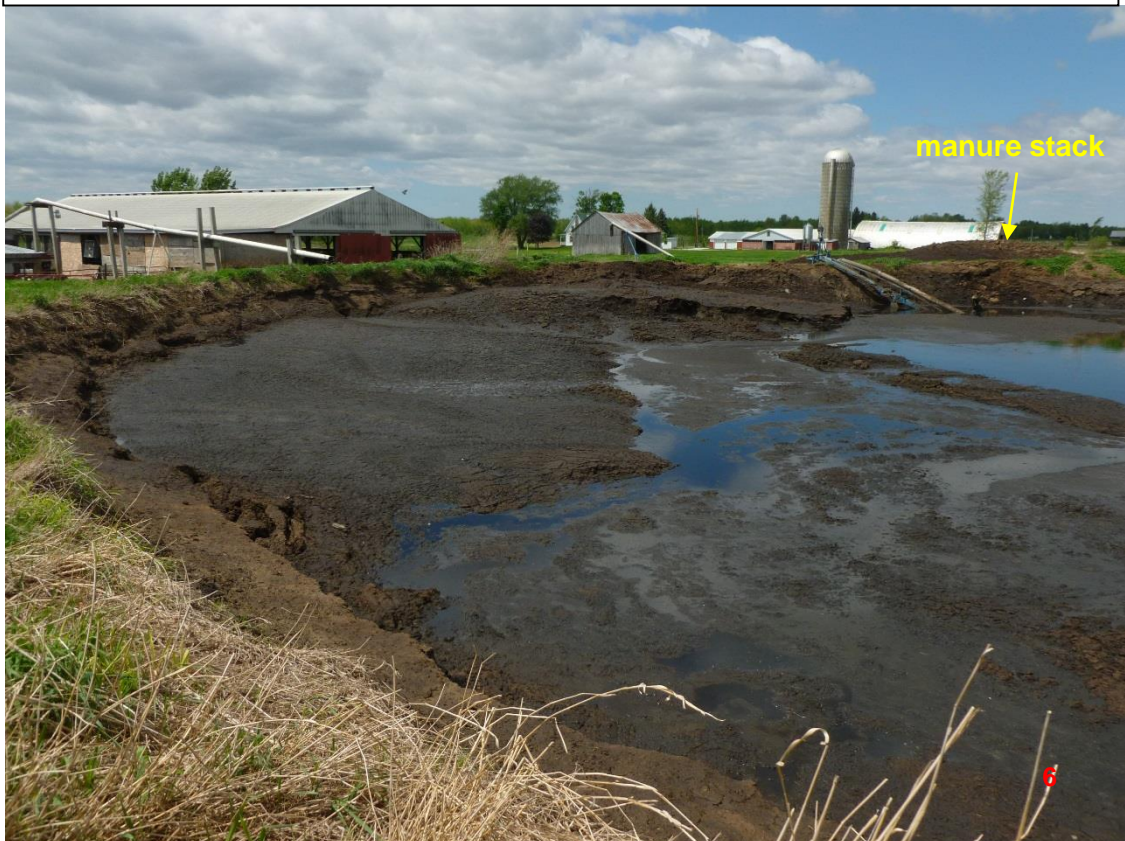
Photo 6 – Crosswinds Dairy, 98 Martell Rd., Alburgh, VT – 05/20/15
View of the Main manure pit.

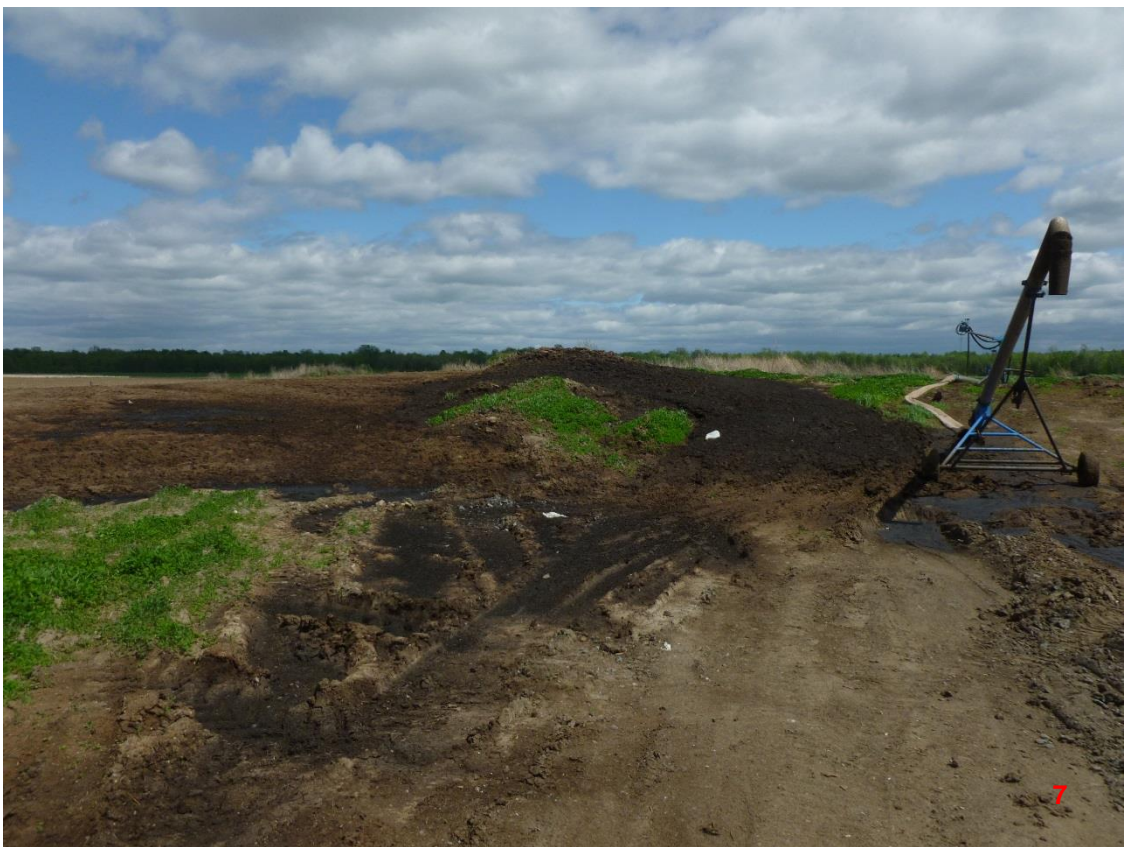
Photo 7 – Crosswinds Dairy, 98 Martell Rd., Alburgh, VT – 05/20/15
Manure stacking outside the Main pit.
